Load Test Report

Report Number: 34162 June 24, 2016

Client: KLEVAKLIP SYSTEMS PTY LTD Page 1 of 3

Sample Identification: Nylon joist hangers 140mm x 45mm

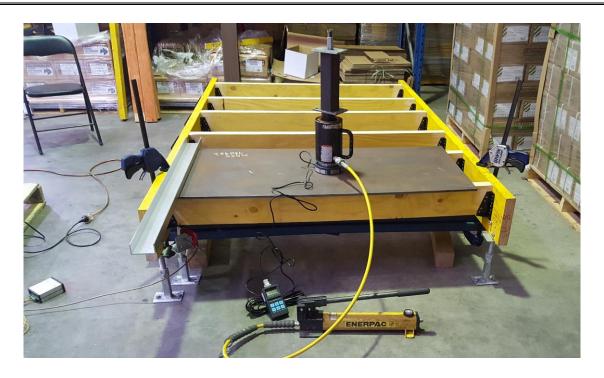
Figure 1: Joist hangers test setup

<u>Test Setup:</u> Joist hangers were installed by client with joist span on 1.5m and 0.45m centres. Loads were distributed over the majority of the span via a steel plate testing four joist hangers simultaneously.

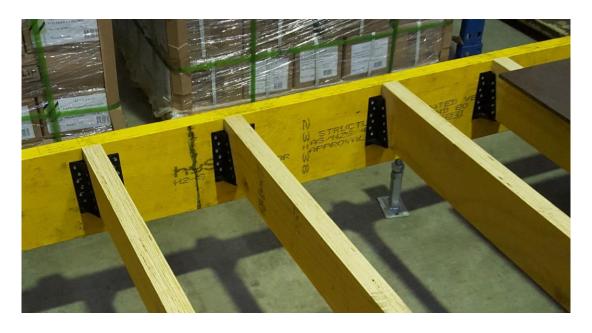
Figure 2: Example of joist hanger tested

Compliance: The joist hangers tested comply with AS1170 for serviceability loading (permanent set < 30% of deflection) and ultimate loading (no collapse under load) when loaded to the loads outlined in AS1170.1 part 3.4.
