## Load Test Report

| Report Number: | WS136942-2 | February 26, 2021 |
| Client: | KLEVAKLIP SYSTEMS PTY LTD | Page 1 of 4 |
| Test Requirements: | Load test of adjustable supports per the client's instructions. | |

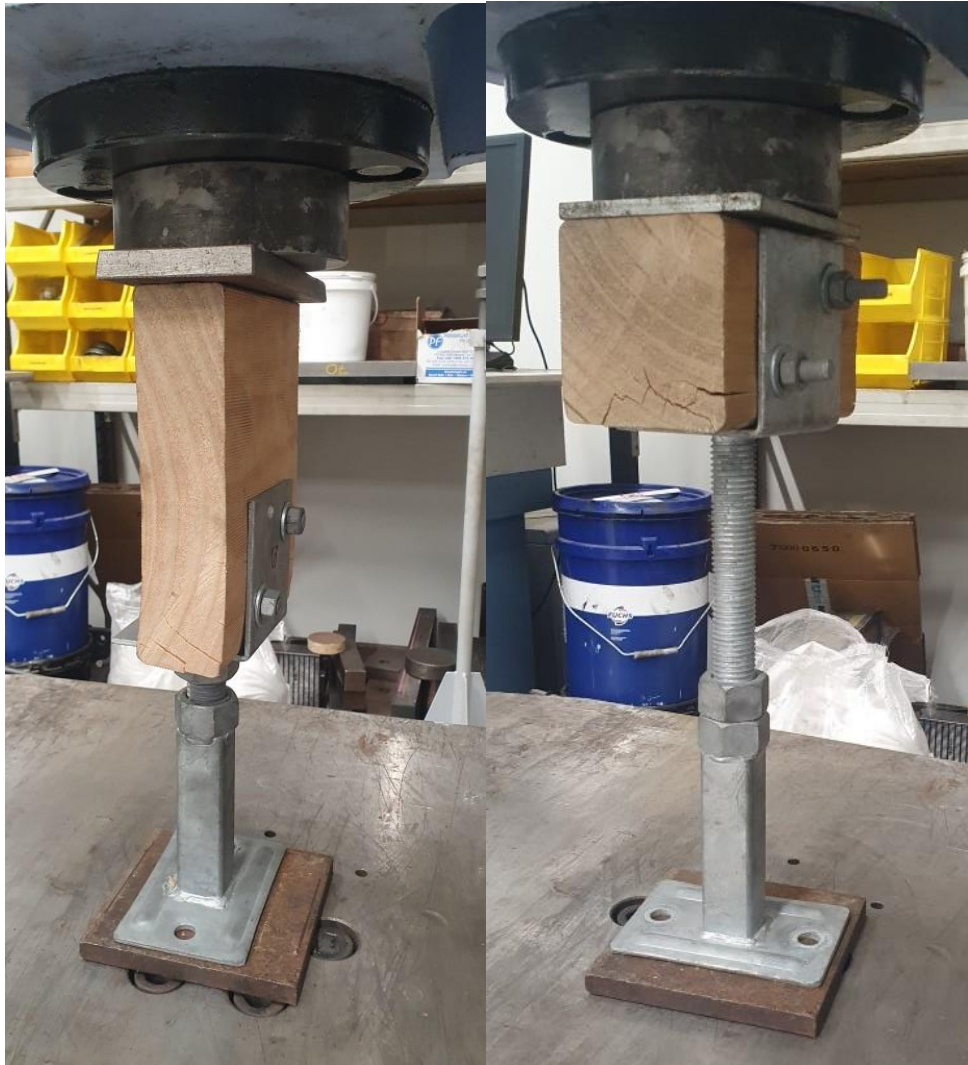
Figures 1-2: Example of test setups used.

**Test Setup:** Samples A, B, E and F were set to the minimum height and samples C, D, G and H were set to the maximum height of 290mm (measured from base to bottom of the L-bracket. Bearer for each test were fixed to the L-bracket using two M10 hex bolts and nuts.

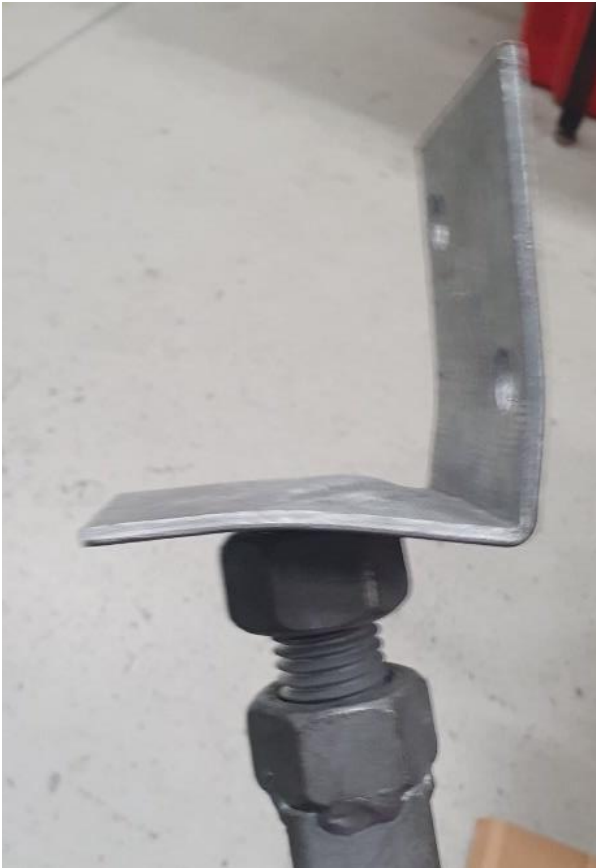
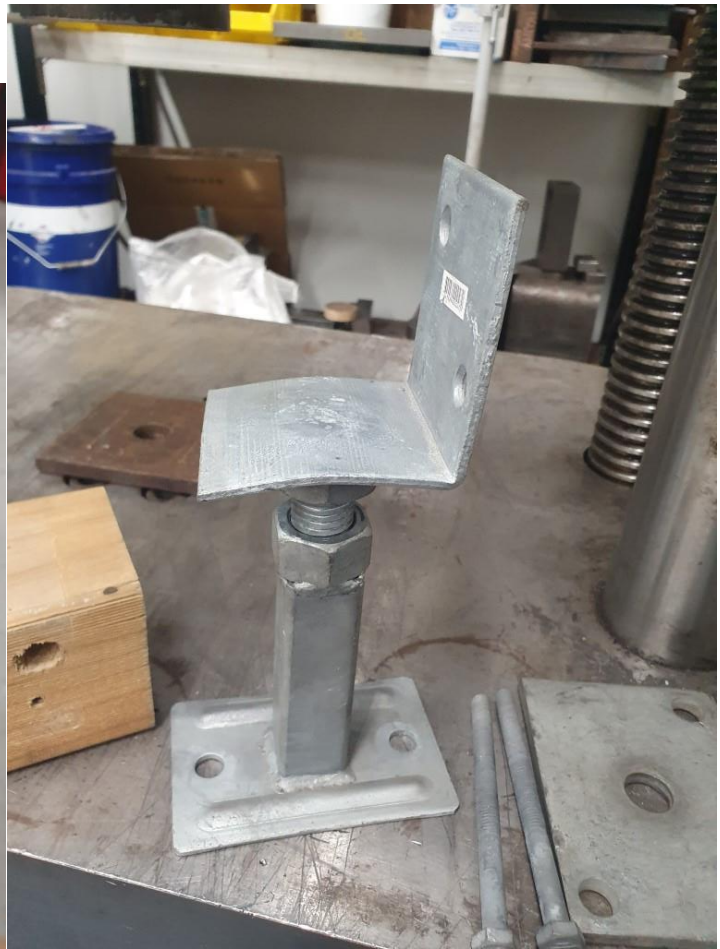
Figures 3-4: Example of damage observed on amps after testing.

| Sample | Bearer size (mm) | Height | Proof load (kN) | Maximum load (kN) | Observations |
|---|---|---|---|---|---|
| A | 190x45 | Minimum | 20 | 36.04 | Test stopped as bearer cracking, load dropped, damage to L bracket |
| E | 90 x 90 | Minimum | 20 | 50* | Test stopped, some deformation in L bracket and bearer cracking |
